L31 Altima (MY02-06) & A34 Maxima (Redacted - CBI)

Floor Pan Corrosion Issue Up-date and Draft direction of campaign

**2013/9/19
NNA FQA**

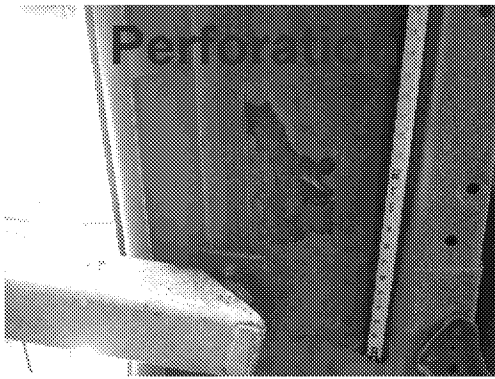
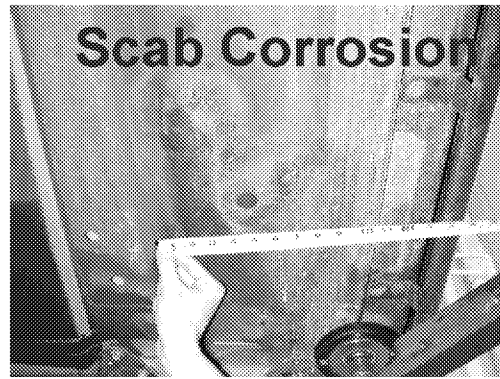
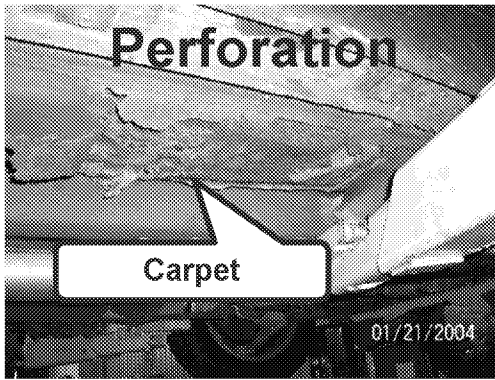
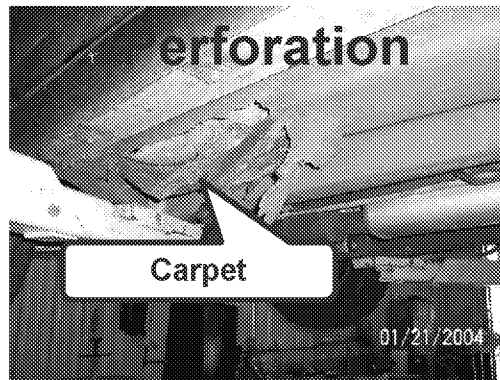
Incident Summary

Countermeasure <p>No countermeasure was applied due to end of production.</p>		
Cause <p>Improper application of the butyl patch on the inner side of the floor assembly caused an insufficient seal condition.</p>			Field Action (if TC decides to campaign) <p>Inspect for corrosion severity and repair as necessary. Bolt on patch using special campaign parts. Approx. cost is approx. \$400 per vehicle if both side. (Parts: \$150, Labor: \$250)</p>

Water and salt can enter between the floor panels through a hole in the floor assembly. And then, the corrosion was created between panels.

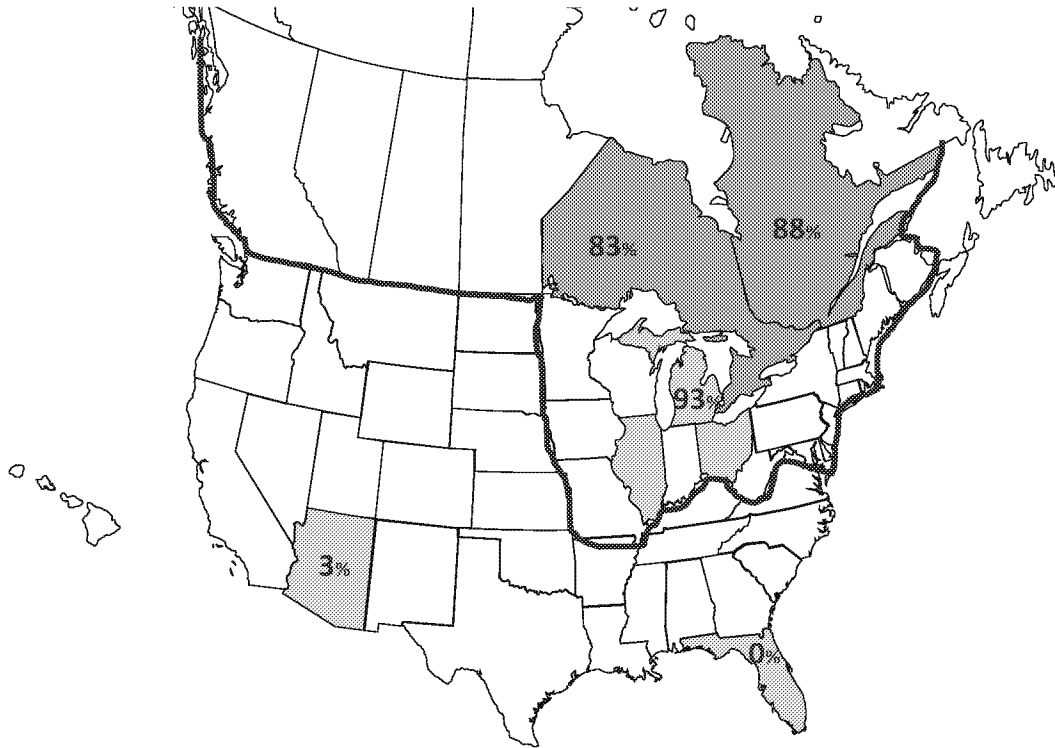
In-Use Vehicle Inspection Summary (Area)

- 98 total vehicles were reviewed from four separate regions
- Vehicles were selected via random selection by TSM group at dealers
- Corrosion Incident rate
Salt area: Approx 90% corrosion rate (USA & CAN combined)
Non-Salt: Approx 3% corrosion rate

Vehicle Condition				
Region Type	Areas Surveyed	Total Vehicles Reviewed	No Rust Present	Rust	Perforation	Comments
Canada	Redacted - CBI					
Canada						
US Salt	Michigan, Ohio, Illinois	29	2 (7%)	27 (93%)	24 (83%)	
US Non-Salt	Florida, Arizona	29	28 (97%)	1 (3%)	0 (0%)	Phoenix vehicle had faint rust on LH side
